Communication Interface Module Replacement (Late Production(F1) OnStar)

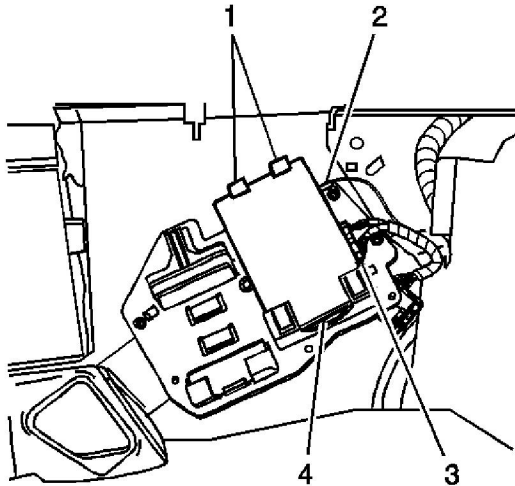
2. Disconnect the antenna (2) and electrical connections (3) from the vehicle communication interface module (VCIM) (4).
3. Release the VCIM retaining tabs (1).
4. Slide the vehicle VCIM (4) out of the electrical component mounting bracket.

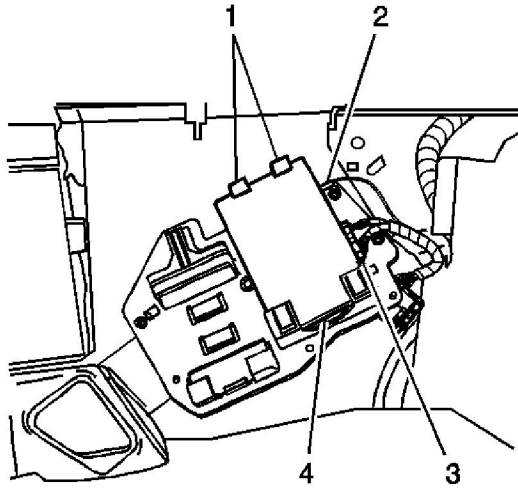
1. When replacing the VCIM, record the 11-digit electronic serial number (ESN) and the 10-digit station identification (STID) number from the label on the new VCIM (4).
2. Slide the VCIM (4) into the electrical component mounting bracket.
3. Push in on the top of the VCIM (4) until an audible click is heard, indicating the retaining tabs (1) have securely fastened the VCIM (4) to the electrical component mounting bracket.
4. Connect the antenna cable (2) and electrical connections (3) to the VCIM (4).
5. Install the rear compartment trim. Refer to [Rear Compartment Trim Panel Replacement](#) .
