Communication Interface Module Replacement

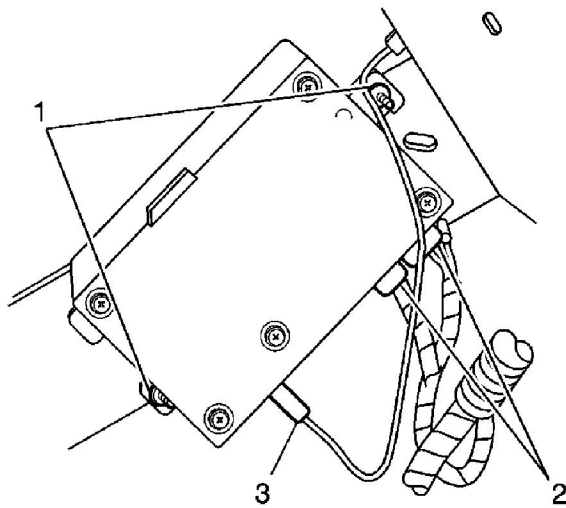
2. Disconnect the antenna (3) and electrical connections (2) from the vehicle communication interface module (VCIM).
3. Remove the bolts (1) securing the VCIM.
4. Remove the vehicle VCIM from the vehicle.
