Communication Interface Module Replacement

Removal Procedure

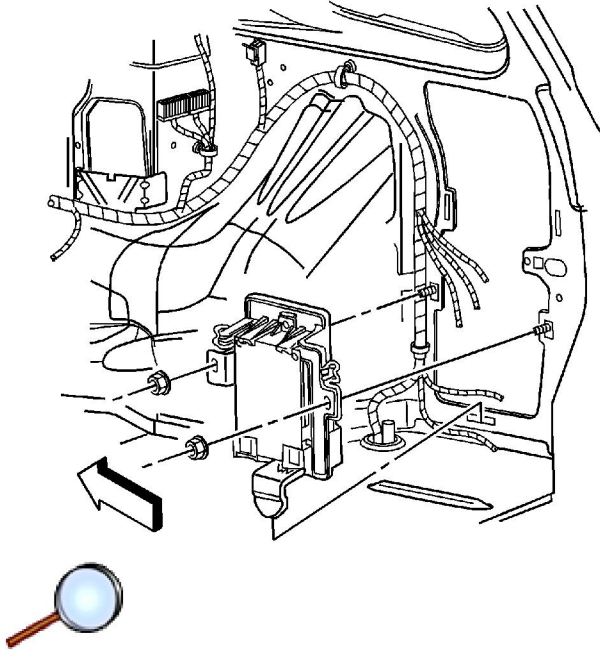
Important: The vehicle communication interface module (VCIM) has a specific set of unique numbers that tie the module to each vehicle. These numbers, the 10-digit station identification and the 11-digit electronic serial number, are used by the National Cellular Network and OnStar® to identify the specific vehicle. Because these numbers are tied to the vehicle identification number of the vehicle, you must never exchange these parts with those of another vehicle.

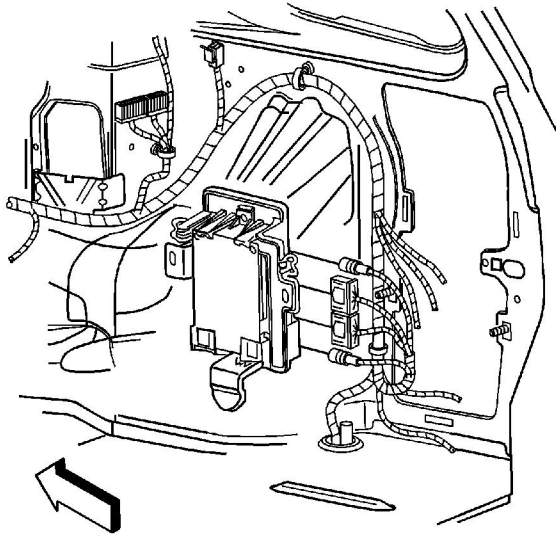
1. Remove the right rear body side trim. Refer to [Body Side Rear Trim Panel Replacement](#) in Interior Trim.
2. Remove the nuts securing the OnStar® module to the vehicle body.

3. Disconnect all the electrical connectors from the module.
4. Remove the module from the vehicle.

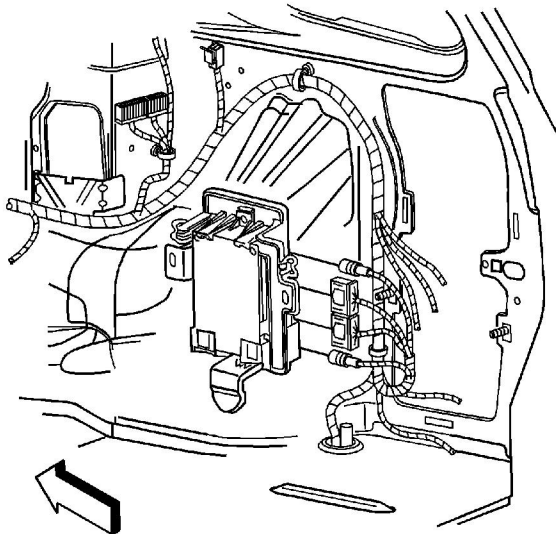
1. When replacing the VCIM, record the 11-digit electronic serial number (ESN) and the 10-digit station identification (STID) number from the label on the new VCIM.
2. Reconnect the electrical connectors the module.

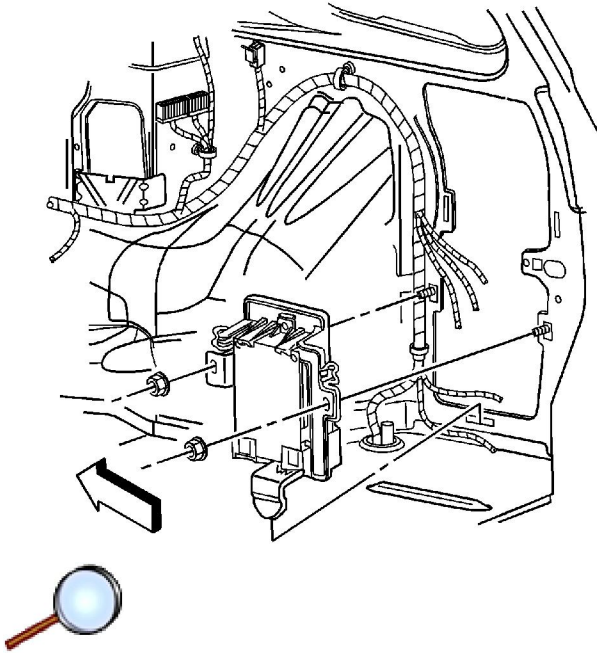
3. Install the module onto the vehicle.

Tighten the nuts to 9 N·m (80 lb in).
