Communication Interface Module Replacement

Removal Procedure

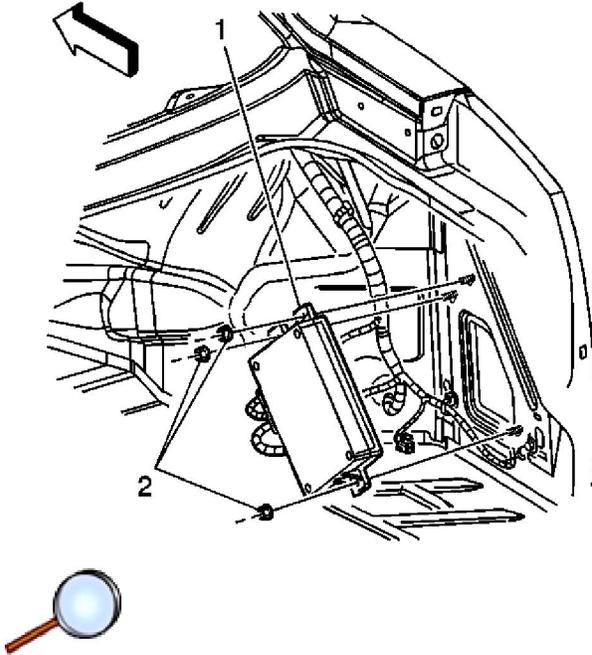
Important: The communication interface module (CIM) has a specific set of unique numbers that tie the module to each vehicle. These numbers, the 10-digit station identification (STID) and the 11-digit electronic serial number (ESN), are used by the National Cellular Network and OnStar® to identify the specific vehicle. Because these numbers are tied to the vehicle identification number of the vehicle, you must never exchange these parts with those of another vehicle.

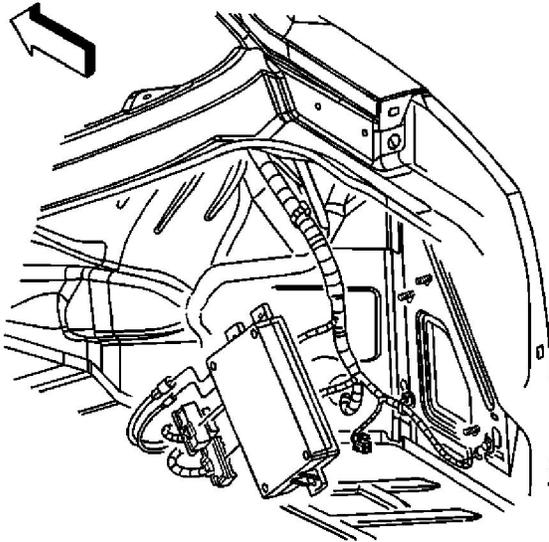
1. Remove the right rear compartment trim. Refer to [Rear Compartment Trim Panel Replacement](#).
2. Remove the nuts (2) securing the module (1) to the vehicle body.

3. Disconnect all the electrical connectors from the module.
4. Remove the module from the vehicle.

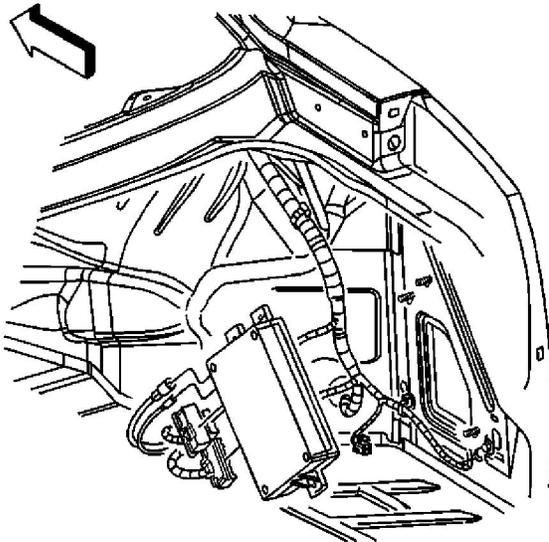
1. When replacing the CIM, record the 11-digit ESN and the 10-digit STID number from the label on the new CIM.
2. Reconnect the electrical connectors the module.

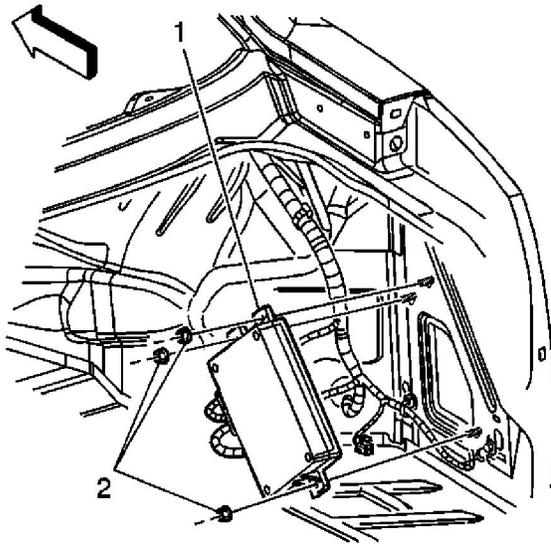
3. Install the module onto the vehicle.

Tighten the nuts to 9 N·m (80 lb in).
