Communication Interface Module Replacement

Removal Procedure

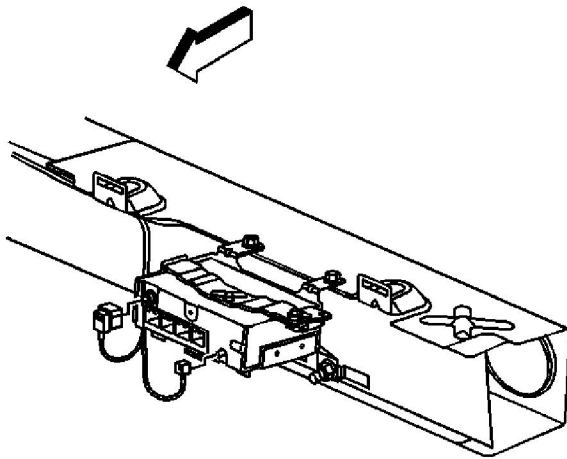
1. Loosen and move the rearward center console for access to the center trim panel. Refer to [Console Replacement](#) .
2. Remove the screws that hold the center trim panel to the instrument panel (I/P). Refer to [Instrument Panel Center Trim Panel Replacement](#) .

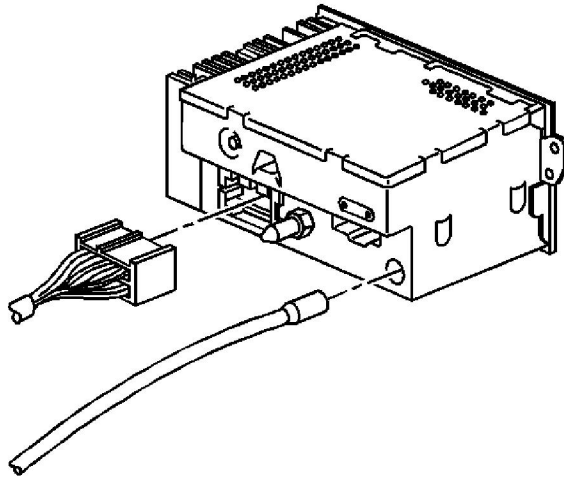
3. Remove the screws that hold the communication interface module to the I/P.

4. Disconnect the antenna and the electrical connections from the communication interface module.
5. Remove the communication interface module.

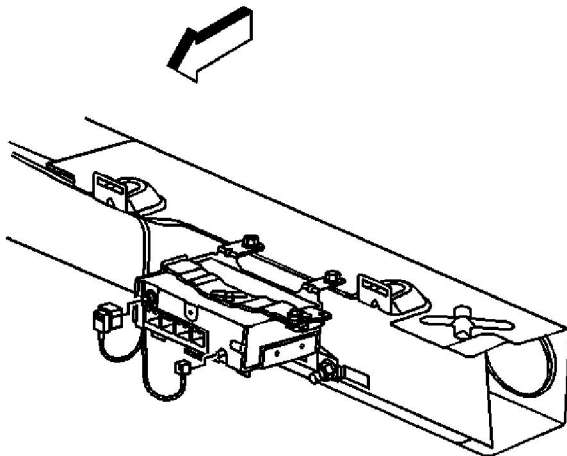
1. When replacing a VCIM, record the 11-digit electronic serial number (ESN) and the 10-digit station identification (STID) number from the label on the new VCIM.

2. Connect the electrical and the antenna connections to the communication interface module.

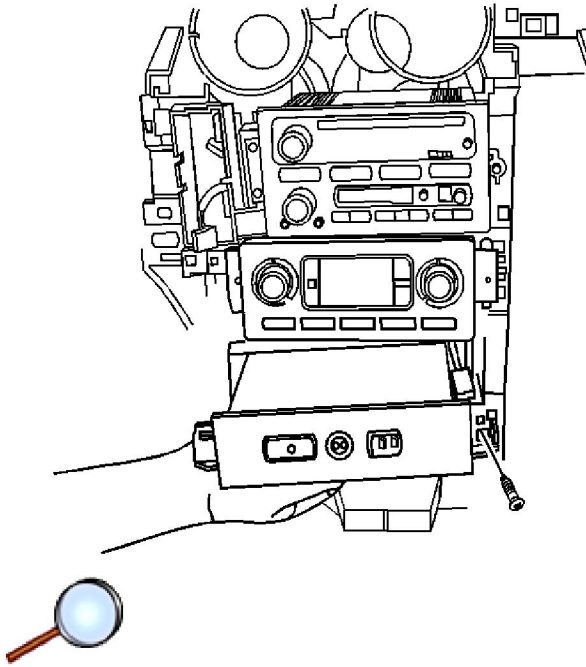
3. Align the communication interface module with the center stack I/P substraight and tighten the mounting screws.

Tighten the screws to 2 N·m (18 lb in).
