> 2008 Saturn Astra | Astra (VIN A) Service Manual | Driver Information and Entertainment | Cellular, Entertainment, and Navigation | Repair Instructions | Document ID: 2152457

Communication Interface Module Replacement (Left Side)

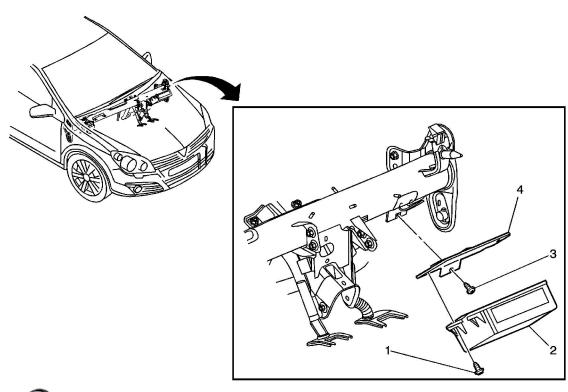
Callout	Component Name	
Preliminary Procedure		
Pemove	the driver knee bolster. Refer to Driver Knee Bolster Replacement.	
IKemove		
	Communication Interface Module Bolt (Qty: 1)	
1 1	Notice: Refer to <u>Fastener Notice</u> in the Preface section.	
	Tighten	
	4 N·m (35 lb in)	
	Communication Interface Module	
	Procedure	
2		
	1. Disconnect the electrical connections.	
	2. Refer to Control Module References for programming and set up procedures.	
	Communication Interface Module Bolt (Otyation). All rights reserved.

Notice: Refer to Fastener Notice in the Preface section.	
3	Tighten	
	4 N·m (35 lb in)	l
4	Mobile Telephone Transceiver
