Communication Interface Module Replacement

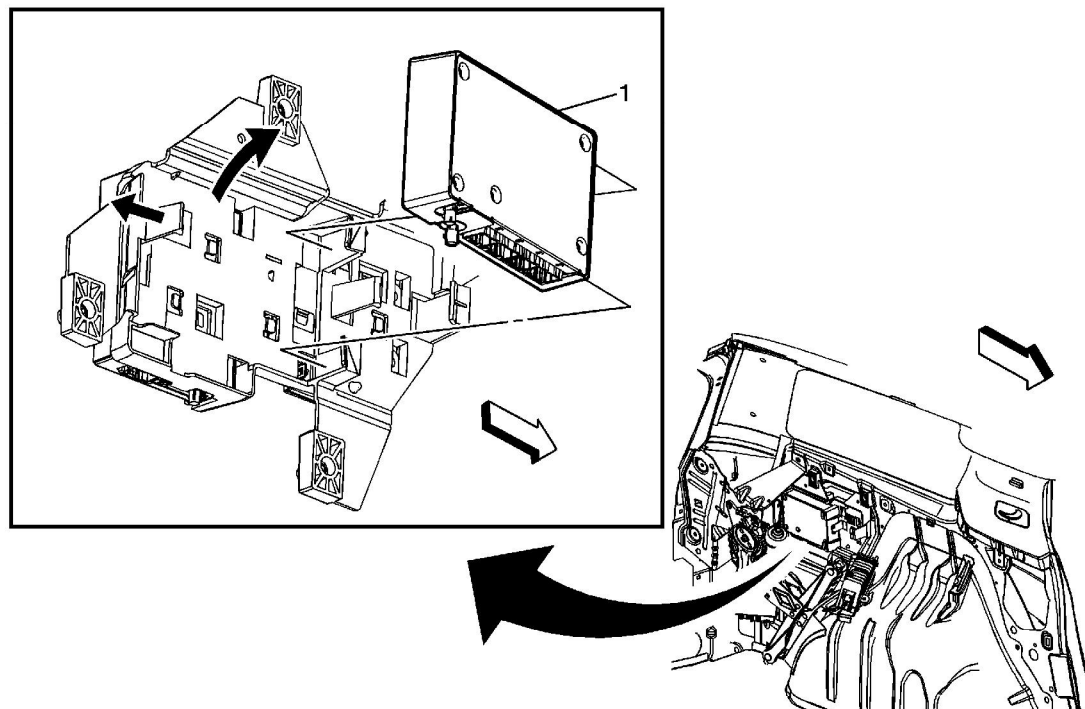
Callout	Component Name
Preliminary Procedure	
Remove the left rear quarter lower trim panel. Refer to Quarter Lower Rear Trim Panel Replacement .	
1	Communication Interface Module
	Procedure
	<ol style="list-style-type: none">1. Disconnect the electrical connectors.2. When replacing the communication interface module be sure to transfer Bluetooth Antenna, if equipped.3. Reprogram the communication interface module if replaced. Refer to Control Module References.4. When replacing the VCIM, record the 11-digit electronic serial number (ESN) and the 10-digit station identification (STID) number from the label on the new VCIM.
Tip	
<ul style="list-style-type: none">• The vehicle communication interface module (VCIM) has a specific set of

unique numbers that tie the module to each vehicle. These numbers, the 10-digit station identification and the 11-digit electronic serial number, are used by the National Cellular Network and OnStar® to identify the specific vehicle. Because these numbers are tied to the vehicle identification number of the vehicle, you must never exchange these parts with those of another vehicle.

- After replacing the vehicle communication interface module, you must reconfigure the OnStar® system. Failure to reconfigure the system will result in an additional customer visit for repair. In addition, pressing and holding the white dot button on the keypad will NOT reset this version of the OnStar® system. This action will cause a DTC to set.
