2005 Saturn VUE - AWD | VUE (VIN Z) Service Manual | Accessories | Cellular Communication | Repair Instructions |

Communication Interface Module Replacement

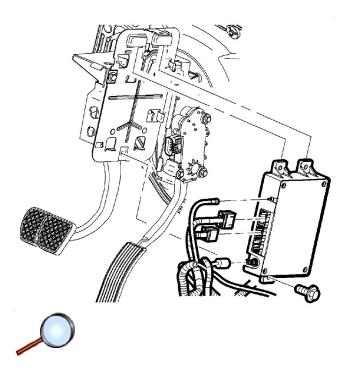
- 1. Remove the fastener located on the bottom of the OnStar® bracket.
- 2. Tilt the module inboard to the center of the vehicle and pull down the communication interface module (CIM)

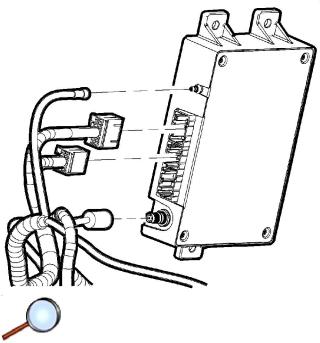
3. Disconnect the electrical connectors, the GPS antenna, and the cellular coax cable.

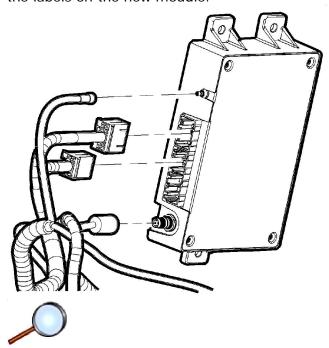
- 2. Connect the electrical connectors, the GPS antenna, and the cellular coax cable.
- 3. Tilt the CIM inboard and install the CIM.

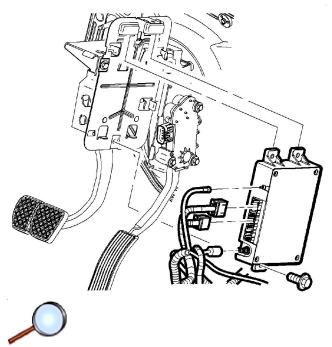
4. Install the CIM fastener.

Tighten the fastener to 10 N⋅m (89 lb in).
