Communication Interface Module Replacement

Removal Procedure

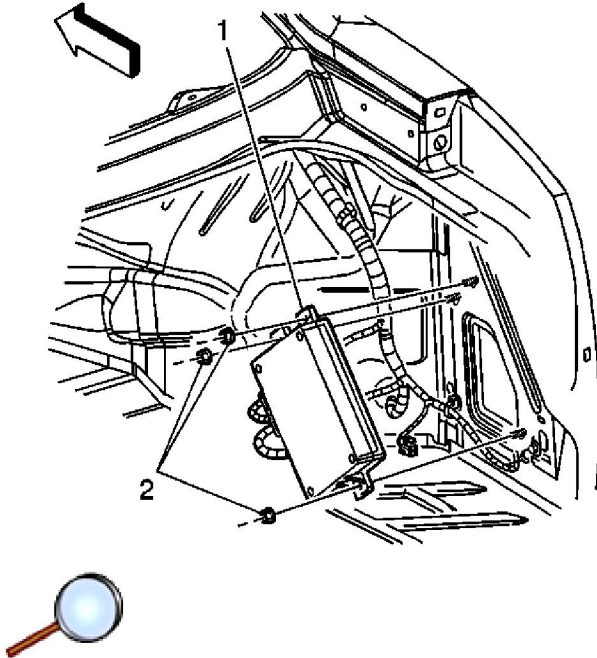
Important: The vehicle communication interface module (VCIM) has a specific set of unique numbers that tie the module to each vehicle. These numbers, the 10-digit station identification and the 11-digit electronic serial number, are used by the National Cellular Network and OnStar® to identify the specific vehicle. Because these numbers are tied to the vehicle identification number of the vehicle, you must never exchange these parts with those of another vehicle.

1. Remove the right rear compartment trim. Refer to [Rear Compartment Trim Panel Replacement](#).
2. Remove the nuts (2) securing the OnStar® module (1) to the vehicle body.

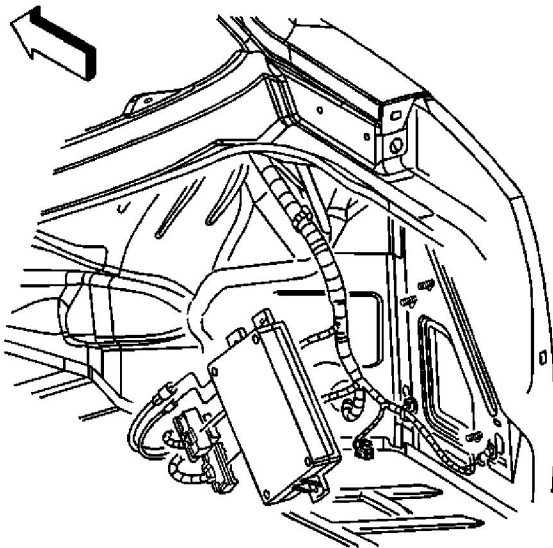
1. When replacing the VCIM, record the 11-digit electronic serial number (ESN) and the 10-digit station identification (STID) number from the label on the new VCIM.
2. Reconnect the electrical connectors the module.
