# Communication Interface Module Replacement

## Removal Procedure

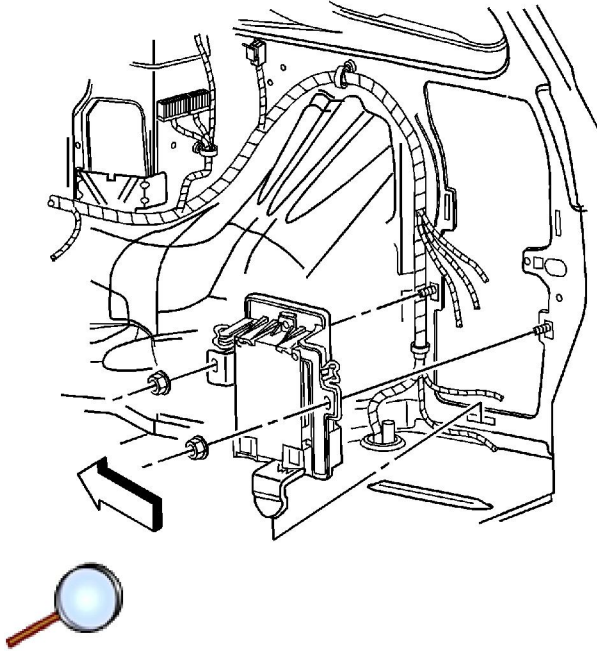
1. Remove the right rear body side trim. Refer to [Body Side Rear Trim Panel Replacement](#) .
2. Remove the nuts securing the OnStar® module to the vehicle body.

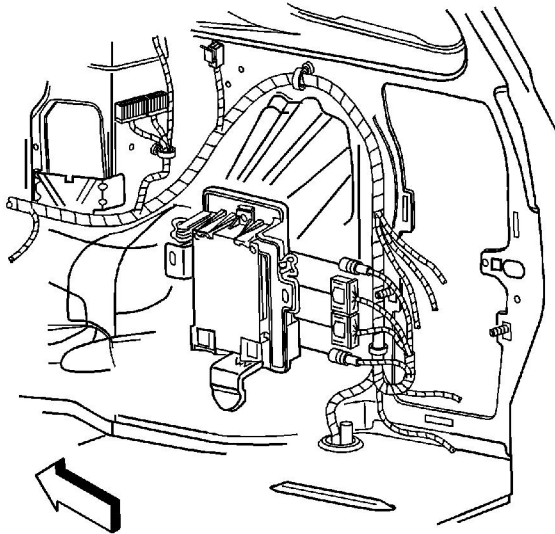
3. Disconnect all the electrical connectors from the module.
4. Remove the module from the vehicle.

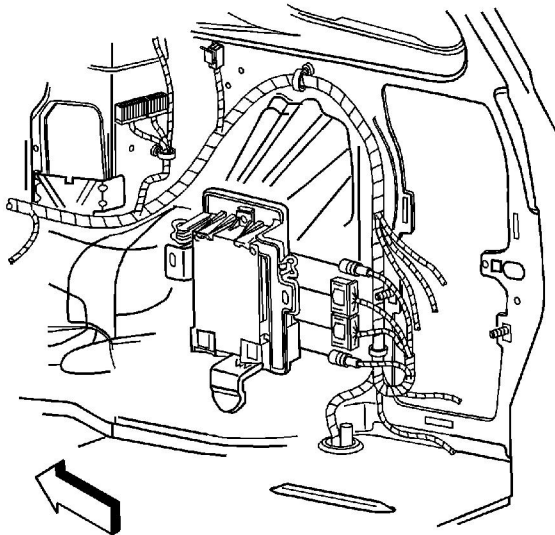
1. When replacing the VCIM, record the 11-digit electronic serial number (ESN) and the 10-digit station identification (STID) number from the label on the new VCIM.
2. Reconnect the electrical connectors the module.

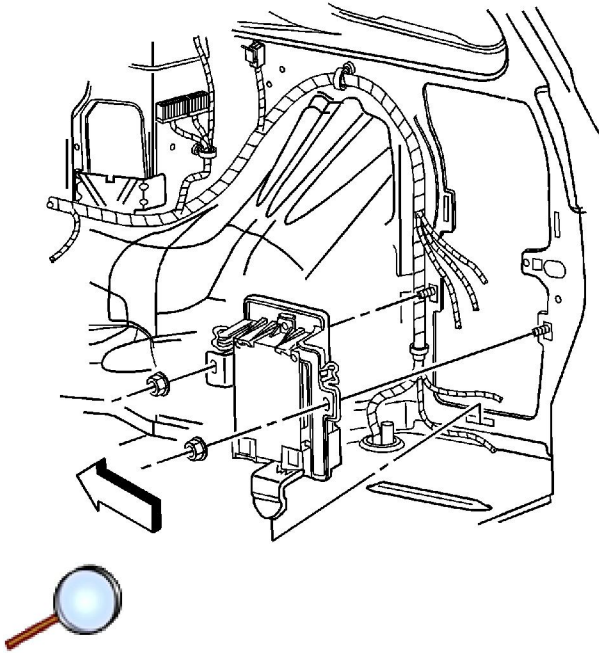
3. Install the module onto the vehicle.

Tighten the nuts to 9 N·m (80 lb in).
