Communication Interface Module Replacement

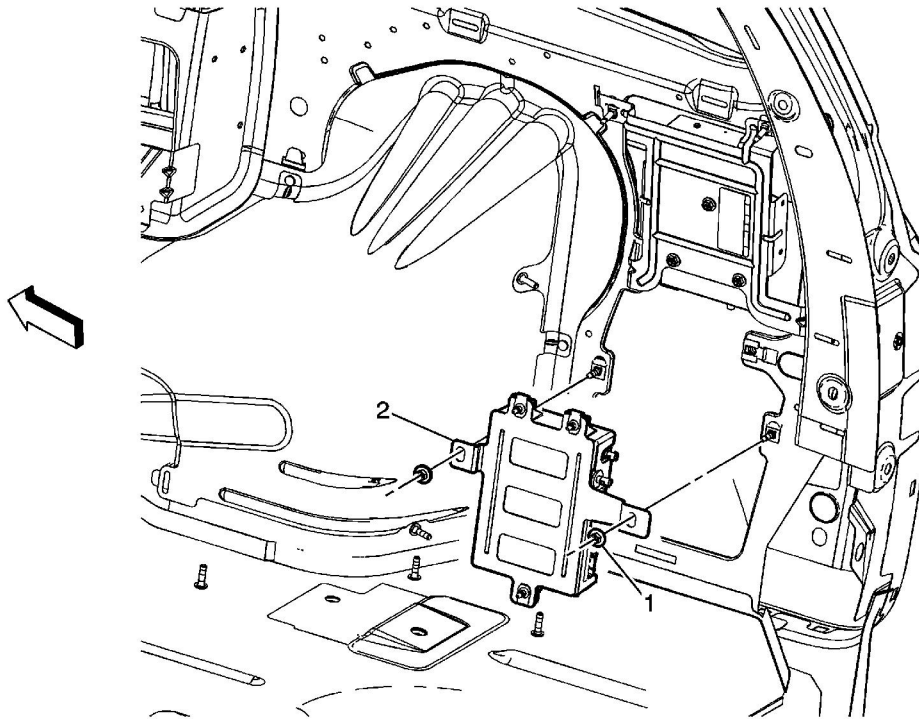
Callout	Component Name
Preliminary Procedure	
Remove the right rear body side trim. Refer to Body Side Rear Trim Panel Replacement .	
1	Communication Interface Module Nut (Qty: 2) Notice: Refer to Fastener Notice in the Preface section. Tighten 9 N·m (80 lb in)
	Communication Interface Module Procedure: <ul style="list-style-type: none"> • Disconnect the electrical connectors. • Reprogram the communication interface module if replaced. Refer to Control Module References . • When replacing the VCIM, record the 11-digit electronic serial number (ESN) and the 10-digit station identification (STID) number from the label on the new VCIM.

- The vehicle communication interface module (VCIM) has a specific set of unique numbers that tie the module to each vehicle. These numbers, the 10-digit station identification and the 11-digit electronic serial number, are used by the National Cellular Network and OnStar® to identify the specific vehicle. Because these numbers are tied to the vehicle identification number of the vehicle, you must never exchange these parts with those of another vehicle.
- After replacing the vehicle communication interface module, you must reconfigure the OnStar® system. Failure to reconfigure the system will result in an additional customer visit for repair. In addition, pressing and holding the white dot button on the keypad will NOT reset this version of the OnStar® system. This action will cause a DTC to set.
