Communication Interface Module Replacement

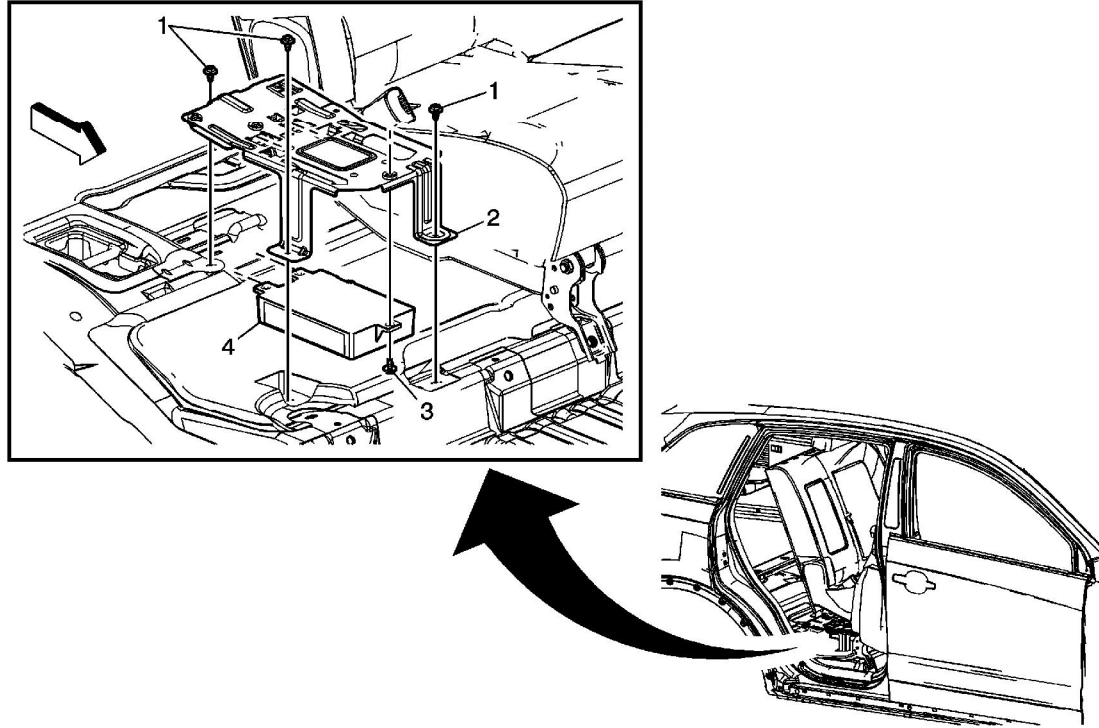
Callout	Component Name
Preliminary Procedure	
Remove the right rear seat. Refer to Rear Seat Replacement .	
1	Communication Interface Module Bracket Bolt (Qty: 3) Caution: Refer to Fastener Caution in the Preface section. Tighten 10 N·m (89 lb in)
2	Communication Interface Module Bracket
3	Communication Interface Module Bolt Caution: Refer to Fastener Caution in the Preface section. Tighten 10 N·m (89 lb in)
	Communication Interface Module <small>© 2012 General Motors Corporation. All rights reserved.</small>

1. Disconnect the electrical connectors.
2. Reprogram the communication interface module if replaced. Refer to [Control Module References](#).
3. When replacing the VCIM, record the 11-digit electronic serial number (ESN) and the 10-digit station identification (STID) number from the label on the new VCIM.
