## Communication Interface Module Replacement

### Removal Procedure

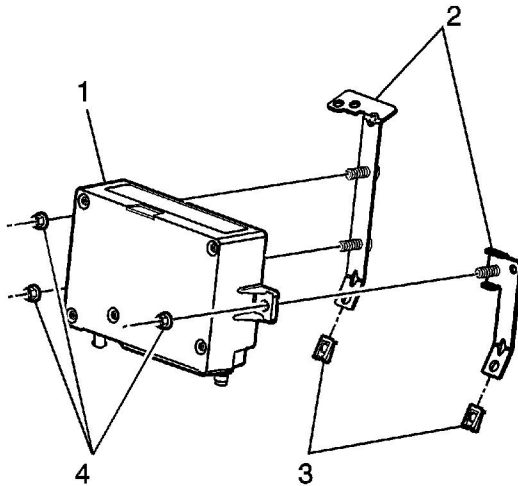
12. Remove the nuts (4) from the VCIM mounting brackets (2).  
13. Remove the mounting brackets (2) from the VCIM (1).

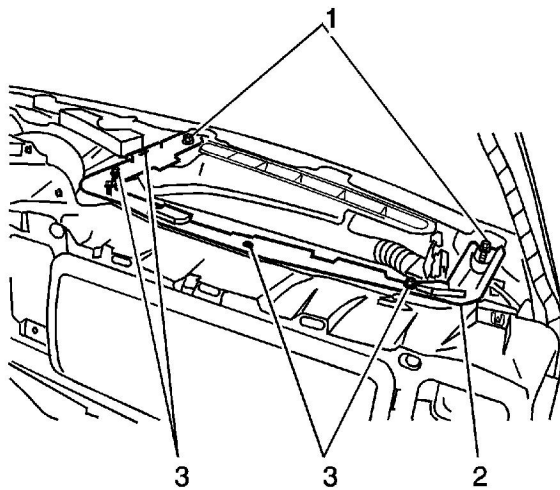
9. Install the passenger side upper I/P bracket (2).
10. Install the I/P upper bracket screws (3).

Tighten the screws (3) to 2 N·m (18 lb in).

11. Install the I/P upper bracket screws (1).

Tighten the screws (1) to 50 N·m (37 lb ft).
