Communication Interface Module Replacement

Removal Procedure

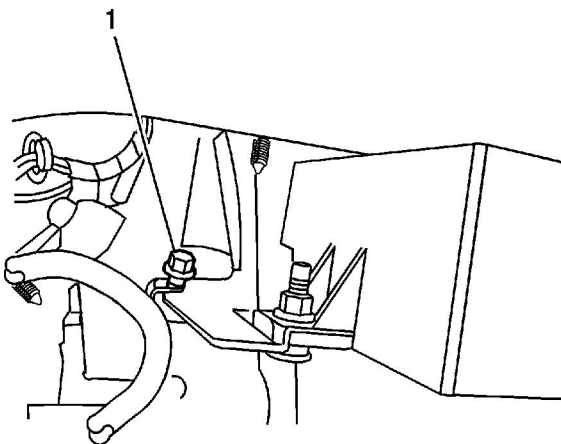
7. Remove the screw (1) retaining the VCIM bracket to the I/P.
8. Remove the retainer from the VCIM bracket.
9. Remove the nuts holding the mounting brackets to the VCIM.
10. If necessary, move the cross-car duct forward slightly in order to make room for the removal of the module.
