2009 Chevrolet TrailBlazer - 2WD | Envoy, TrailBlazer (VIN S/T) Service Manual | Driver Information and Entertainment | Cellular, Entertainment, and Navigation | Repair Instructions | Document ID: 2142772

Communication Interface Module Replacement (TrailBlazer, Envoy)

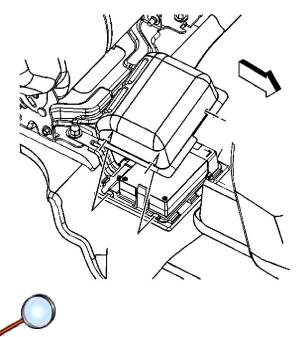
1. Position the right rear seat bottom to a cargo position.

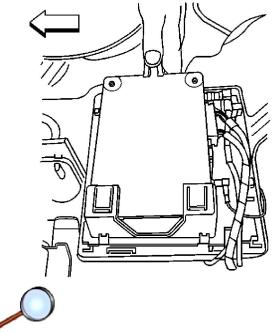
2. Remove the protective cover from the VCIM.

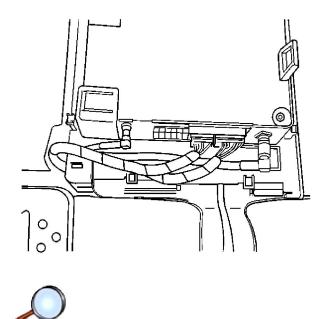
3. Install the module to the upper bracket ensuring the retaining tab is fully seated.

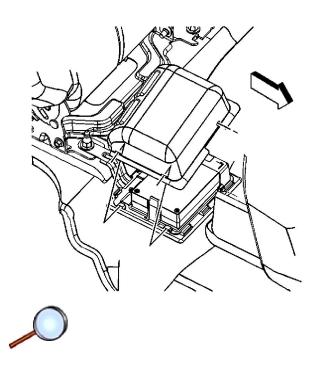
4. Connect the 2 electrical connectors.

Tighten the module thumb screw to a maximum of $0.2 \text{ N} \cdot \text{m}$ (2 lb in).
