## Communication Interface Module Replacement

### Removal Procedure

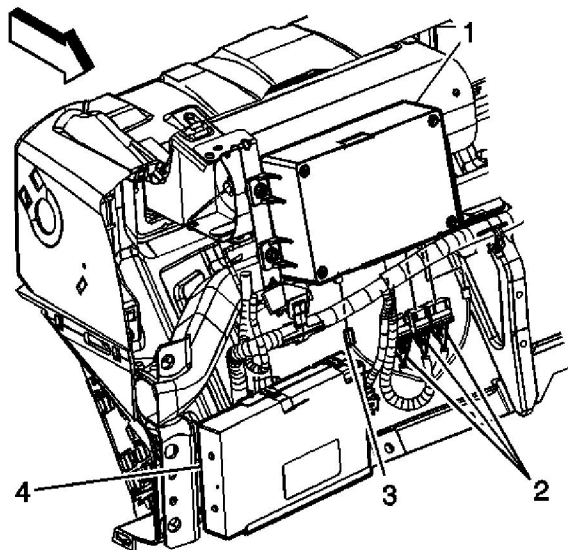
1. Remove the instrument panel (I/P) upper trim panel. Refer to [Instrument Panel Upper Trim Panel Replacement](#).
2. Fully open the I/P storage compartment.
3. Disconnect the electrical connectors (2) from the VCIM (1).
4. Disconnect the coaxial cable (3) from the VCIM.

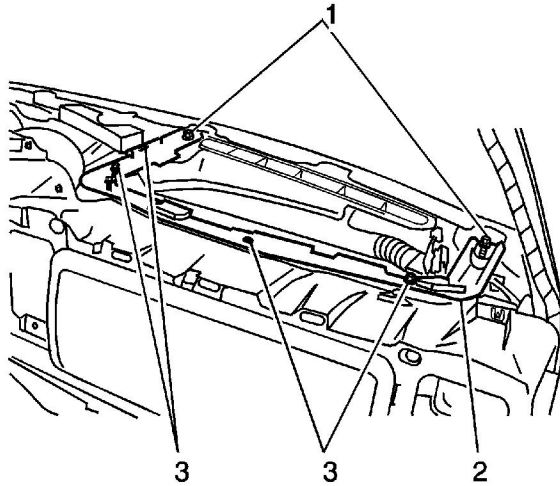
5. Remove the screws (1, 3) from the passenger side upper I/P support (2).
6. Remove the passenger side upper I/P support (2).

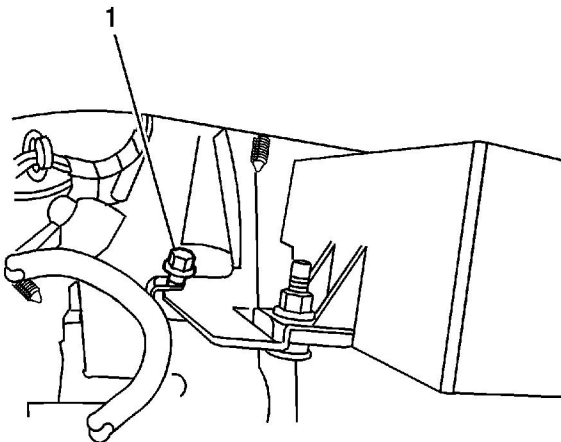
7. Remove the screw (1) retaining the VCIM bracket to the I/P.
8. Remove the retainer from the VCIM bracket.
9. Remove the nuts holding the mounting brackets to the VCIM.
10. If necessary, move the cross-car duct forward slightly in order to make room for the removal of the module.

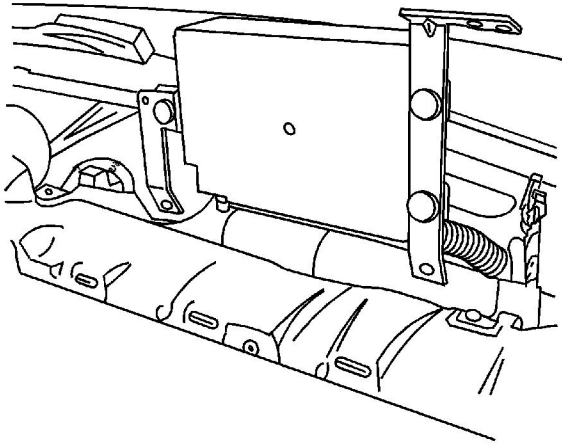
11. Remove the VCIM and bracket assembly from the I/P.

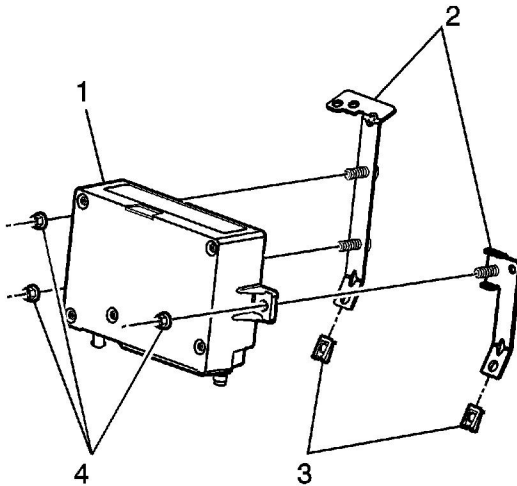
12. Remove the nuts (4) from the VCIM mounting brackets (2).  
13. Remove the mounting brackets (2) from the VCIM (1).

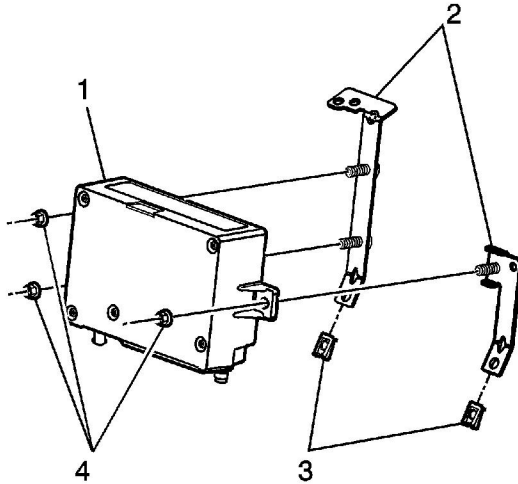
1. If replacing the VCIM, record the 10-digit STID number, and the 11-digit ESN number from the labels on the new module.
2. Ensure the nuts (3) are installed on the module mounting brackets (3).
3. Install the mounting brackets (2) to the VCIM (1).

4. Install the nuts (4).

Tighten the nuts to 2 N·m (18 lb in).

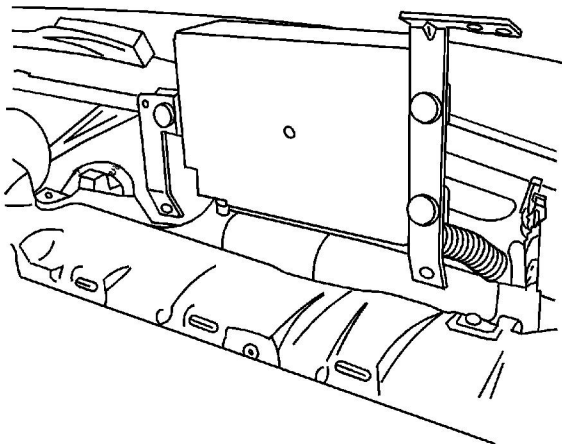
6. Install the VCIM and bracket assembly to the I/P.
7. Install the push in retainer.

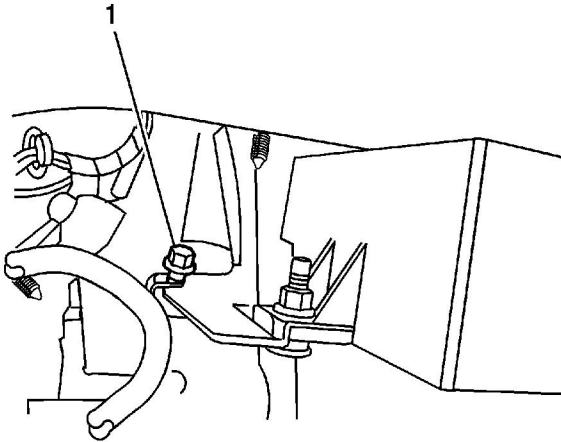
8. Install the VCIM screw (1) to the I/P.

Tighten the screws to 2 N·m (18 lb in).

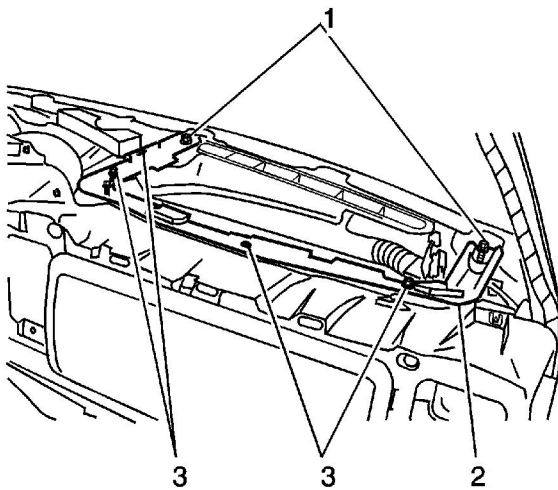
9. Install the passenger side upper I/P bracket (2).
10. Install the I/P upper bracket screws (3).

Tighten the screws (3) to 2 N·m (18 lb in).

11. Install the I/P upper bracket screws (1).

Tighten the screws (1) to 50 N·m (37 lb ft).

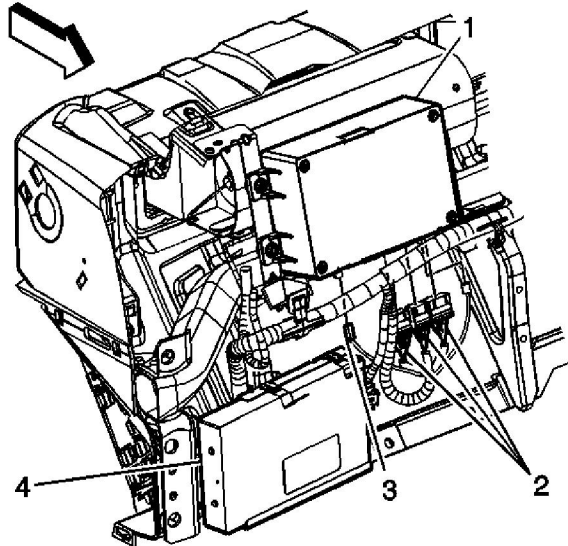
12. Connect the coaxial cable (3) to the VCIM.
13. Connect the electrical connectors (2) to the VCIM.
14. Install the I/P trim panel. Refer to [Instrument Panel Upper Trim Panel Replacement](#) .
