Communication Interface Module Replacement

Removal Procedure

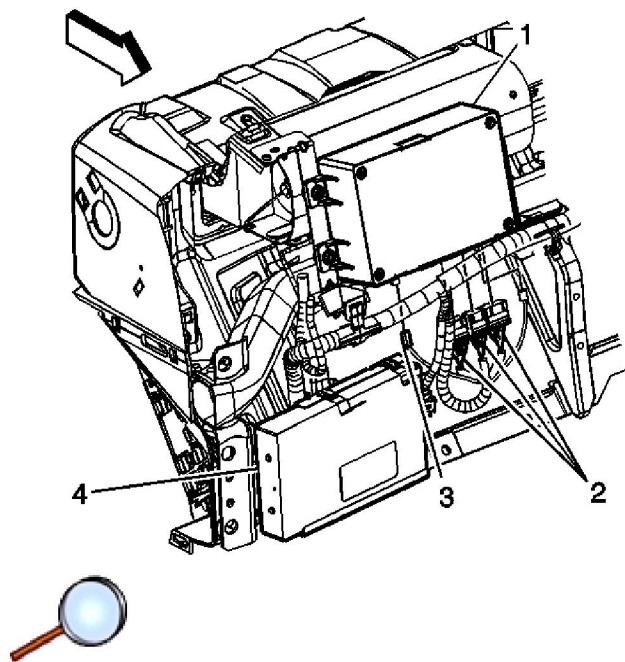
1. Remove the instrument panel (I/P) upper trim panel. Refer to [Instrument Panel Upper Trim Panel Replacement](#).
2. Fully open the I/P storage compartment.
3. Disconnect the electrical connectors (2) from the vehicle communication interface module (VCIM) (1).
4. Disconnect the coaxial cable (3) from the VCIM.

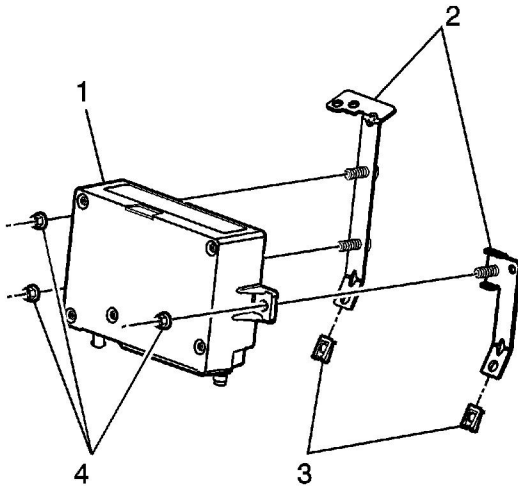
12. Remove the nuts (4) from the VCIM mounting brackets (2).
13. Remove the mounting brackets (2) from the VCIM (1).
