Communication Interface Module Replacement

Removal Procedure

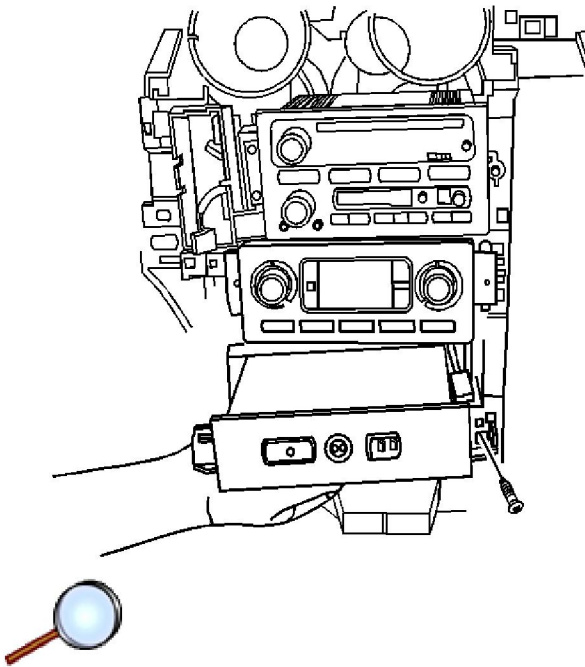
2. Remove the screws that hold the communication interface module to the I/P.
