Communication Interface Module Replacement

Removal Procedure

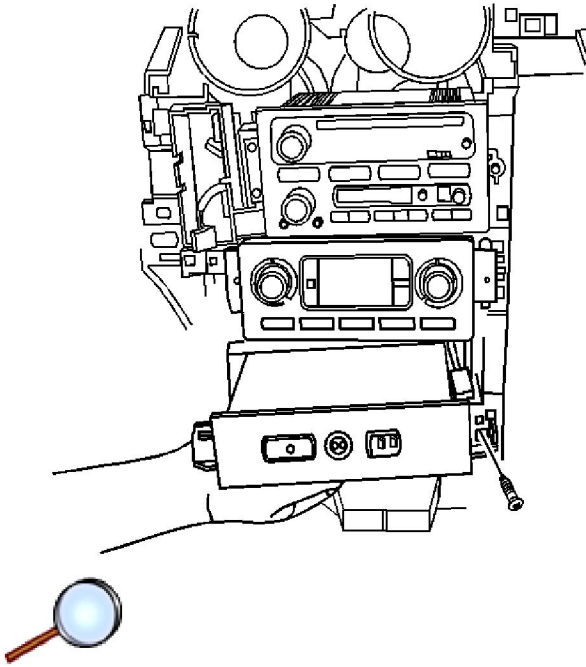
3. Install the communication interface module screws.

Tighten the screws to 2 N·m (18 lb in).
