## Communication Interface Module Replacement

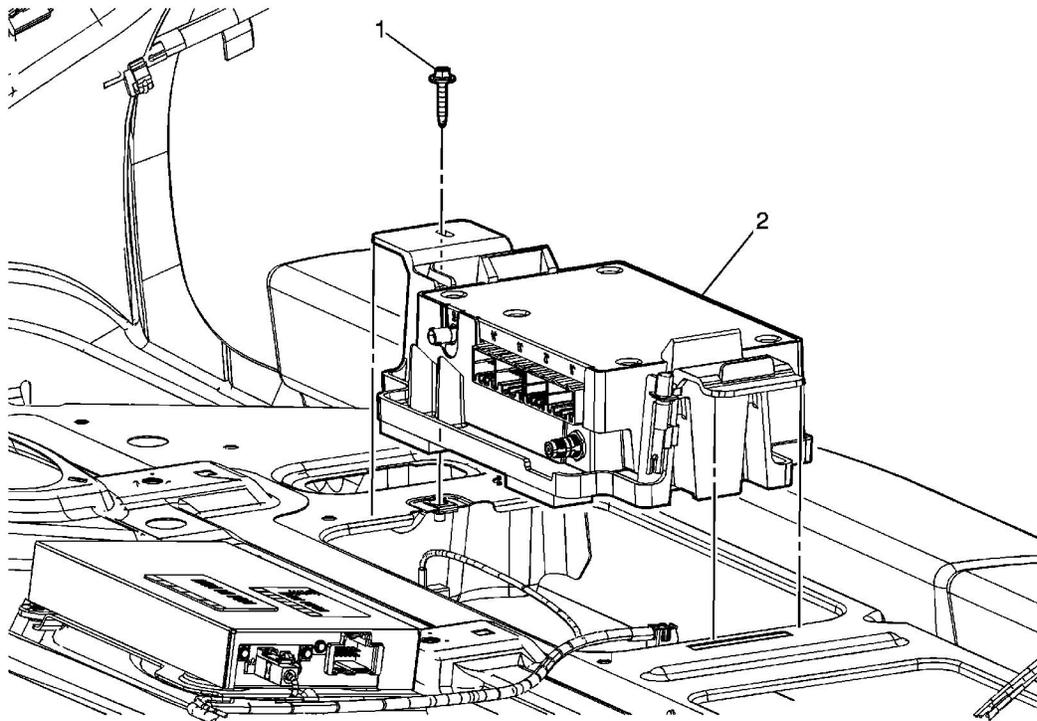
Callout	Component Name
<p><b>Preliminary Procedures</b></p> <ol style="list-style-type: none"> <li>1. Remove the rear shelf trim. Refer to <a href="#">Rear Window Shelf Trim Panel Replacement</a> .</li> <li>2. The vehicle communication interface module (VCIM) has a specific set of unique numbers that tie the module to each vehicle. These numbers, the 10-digit station identification (STID) and the 11-digit electronic serial number (ESN), are used by the National Cellular Network and OnStar® to identify the specific vehicle. Because these numbers are tied to the vehicle identification number of the vehicle, you must never exchange these parts with those of another vehicle.</li> </ol>	
<p>1</p>	<p>Vehicle Communication Module Bolt</p> <p><b>Notice:</b> Refer to <a href="#">Fastener Notice</a> in the Preface section.</p> <p><b>Tip</b> When replacing the VCIM, record the 11-digit ESN and 10-digit STID number from the label on the new VCIM.</p> <p><b>Tighten</b> 9 N·m (80 lb in)</p>

<p>Vehicle Communication Module Assembly</p>

After replacing the VCIM, you must reconfigure the OnStar® system. Failure to reconfigure the system will result in an additional customer visit for repair. In addition, pressing and holding the white dot button on the key pad will NOT reset this version of the OnStar® system. This action will cause a DTC to set.
