Communication Interface Module Replacement

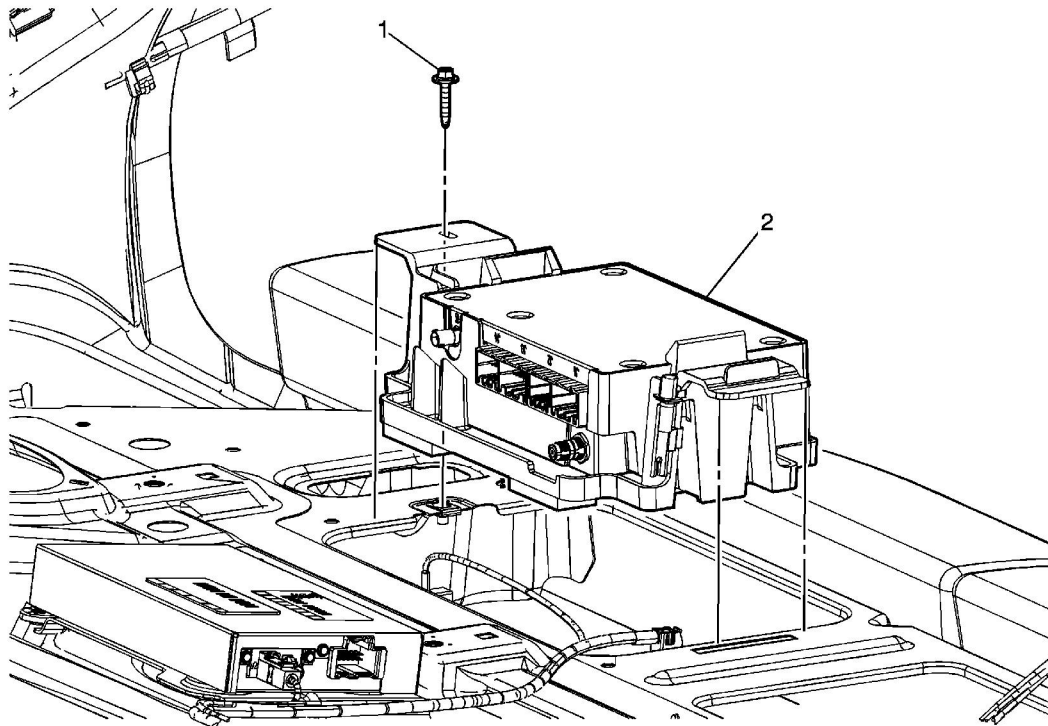
Callout	Component Name
<p>Preliminary Procedures</p> <ol style="list-style-type: none"> 1. Remove the rear shelf trim. Refer to Rear Window Shelf Trim Panel Replacement. 2. The vehicle communication interface module (VCIM) has a specific set of unique numbers that tie the module to each vehicle. These numbers, the 10-digit station identification (STID) and the 11-digit electronic serial number (ESN), are used by the National Cellular Network and OnStar® to identify the specific vehicle. Because these numbers are tied to the vehicle identification number of the vehicle, you must never exchange these parts with those of another vehicle. 	
<p>1</p>	<p>Vehicle Communication Module Bolt</p> <p>Caution: Refer to Fastener Caution in the Preface section.</p> <p>Tip When replacing the VCIM, record the 11-digit ESN and 10-digit STID number from the label on the new VCIM.</p> <p>Tighten 9 N·m (80 lb in)</p>

<p>Vehicle Communication Module Assembly</p>
