Communication Interface Module Replacement

Removal Procedure

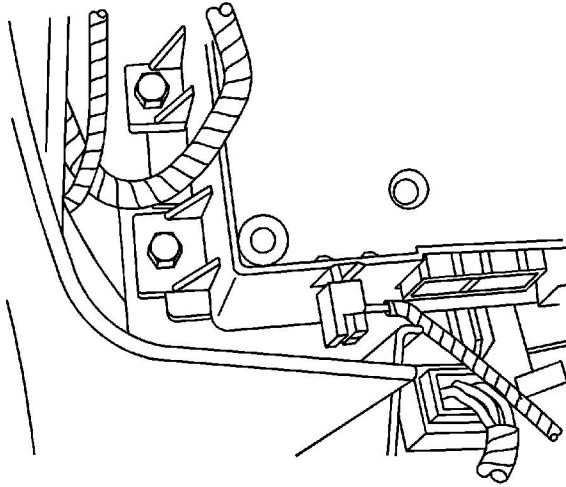
5. Align the module to the vehicle antenna module bracket.

6. Install the communication interface module screws.

Tighten the screws to 2 N·m (18 lb in).
