## Communication Interface Module Replacement

### Removal Procedure

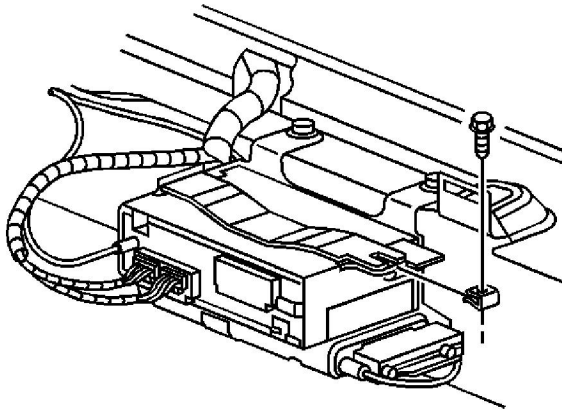
1. Remove the windshield garnish molding. Refer to [Windshield Pillar Garnish Molding Replacement](#) .
2. Remove the upper trim pad. Refer to [Instrument Panel Upper Trim Pad Replacement](#) .
3. Remove the bolt holding the locking strap which secures the VCIM to the bracket.

4. Disconnect the electrical connectors.
5. Disconnect the cell antenna coaxial cable from the VCIM.

6. Remove the VCIM from the bracket and from the vehicle.
