Communication Interface Module Replacement

Removal Procedure

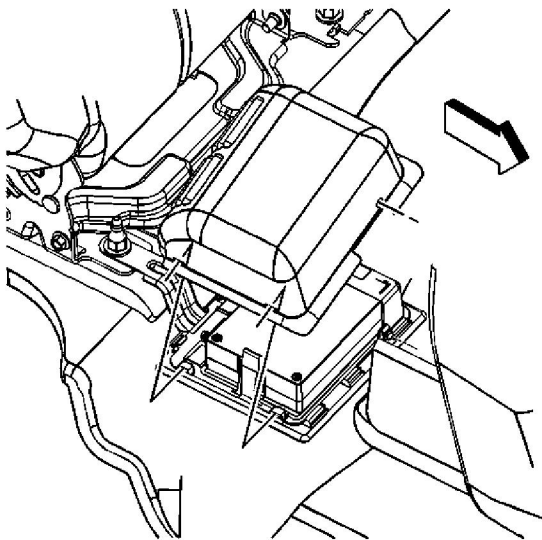
1. Position the right rear seat bottom to a cargo position.

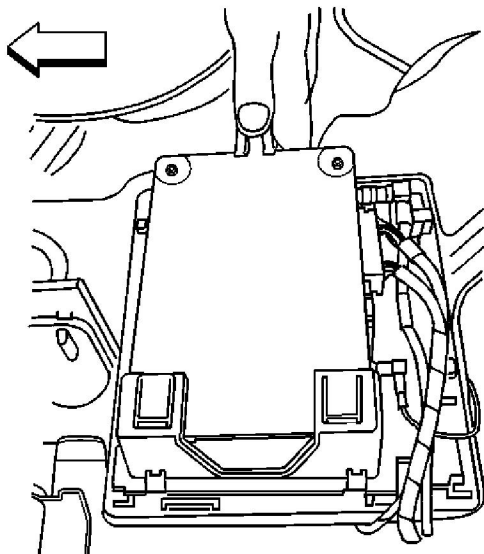
2. Remove the protective cover from the VCIM.

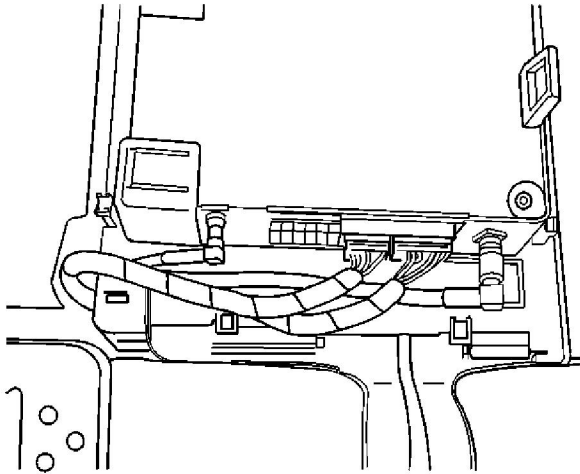
3. Remove the module from the upper bracket by releasing the retaining tab.

4. Remove the electrical connectors from the VCIM.
5. Remove the VCIM from the vehicle

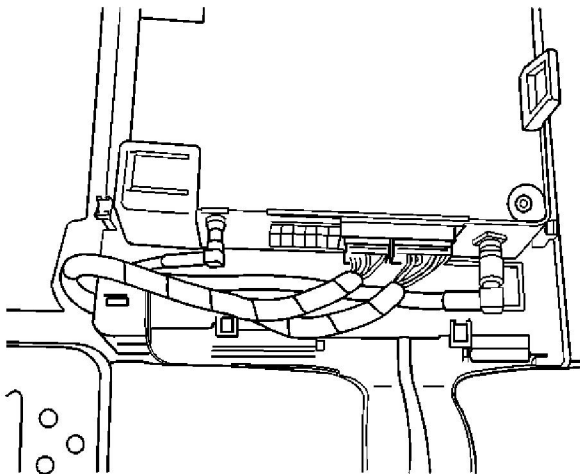
1. If replacing the VCIM, record the 10-digit STID number, and the 11-digit ESN number from the labels on the new module.

2. Install the module to the upper bracket ensuring the retaining tab is fully seated.

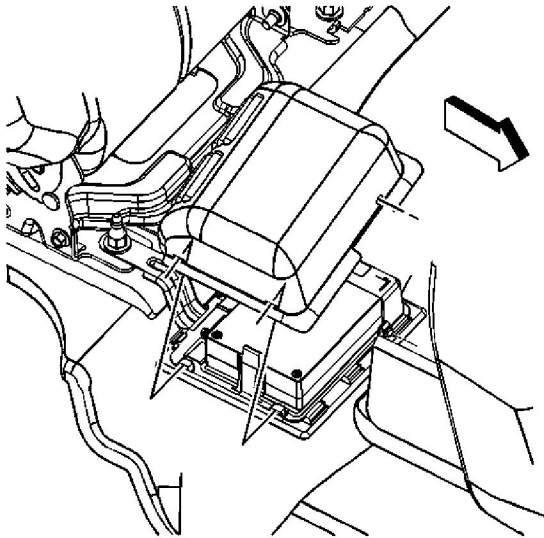
3. Connect the 2 electrical connectors.

Tighten the module thumb screw to a maximum of 0.2 N·m (2 lb in).

Notice: In order to avoid damage to the circuit board, do NOT over-tighten the thumb screws. Using your fingers, apply only a light pressure.
