## Communication Interface Module Replacement

### Removal Procedure

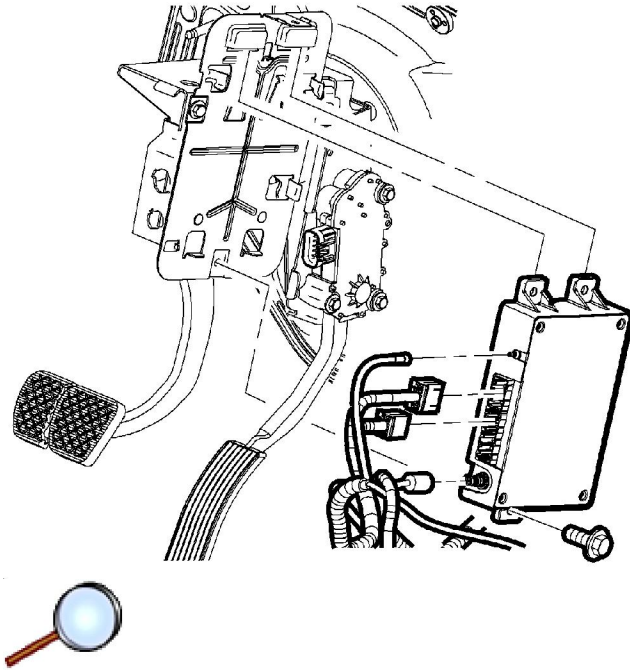
1. Remove the fastener located on the bottom of the OnStar® bracket.
2. Tilt the module inboard to the center of the vehicle and pull down the communication interface module (CIM)

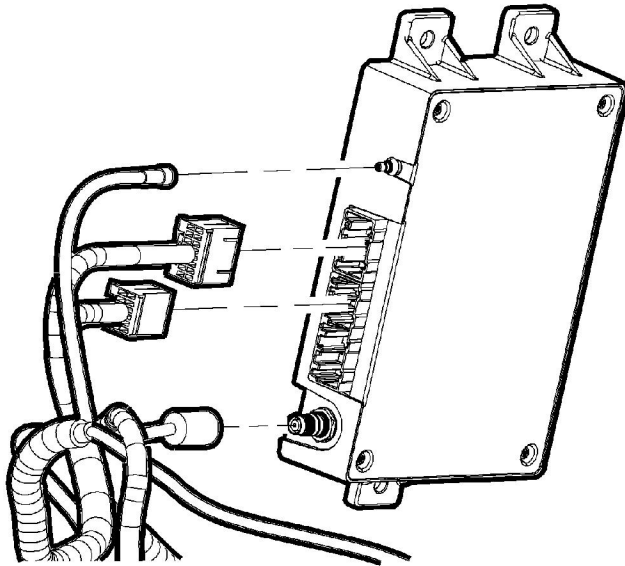
3. Disconnect the electrical connectors, the GPS antenna, and the cellular coax cable.

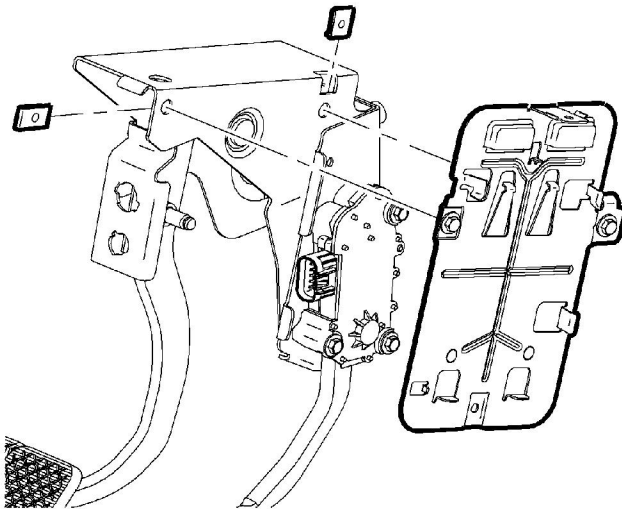
4. Remove the bolts from the OnStar® bracket assembly.
5. Lower the bracket and remove the CIM from the vehicle.

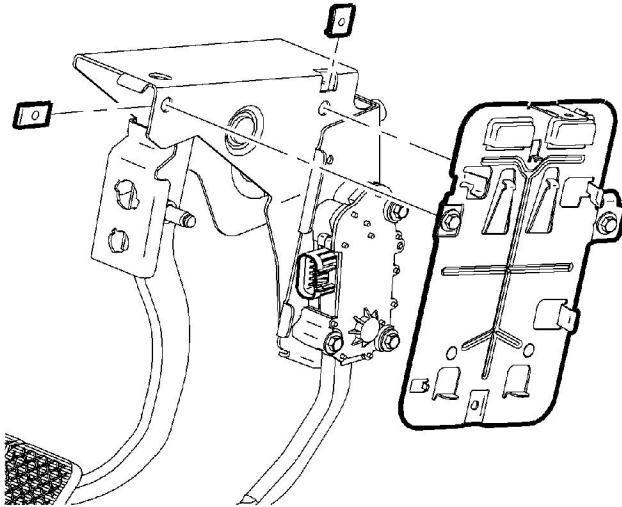
2. Install the OnStar® CIM bracket.

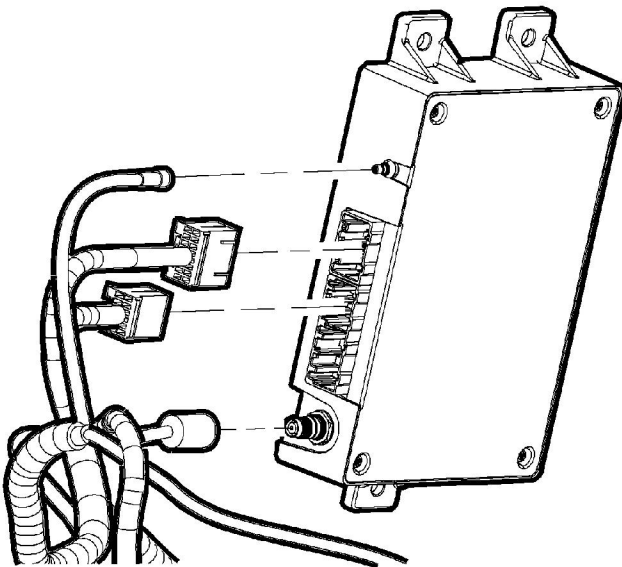
3. Connect the electrical connectors, the GPS antenna, and the cellular coax cable.
4. Tilt the CIM inboard and install the CIM.

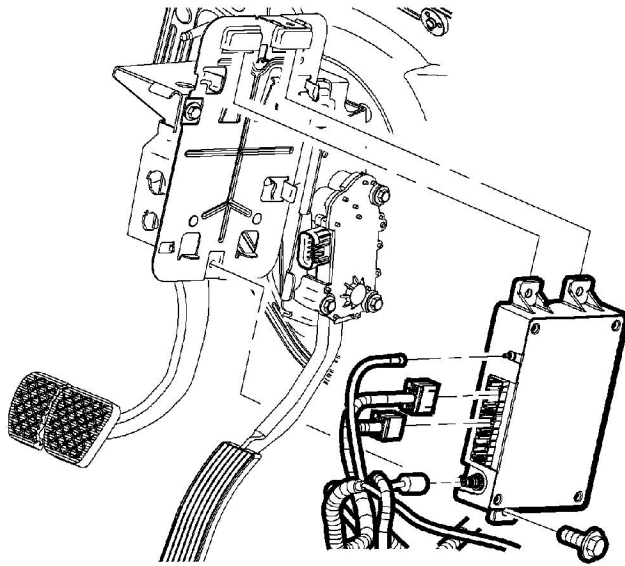
5. Install the CIM fastener.

Tighten the fastener to 10 N·m (89 lb in).
